# Damage scenarios for valves: Identifying the potential for optimisation

Willi Wiedenmann, Kronos AG, D- Neutraubling, e-mail: willi.wiedenmann@krones.com, www.krones.com

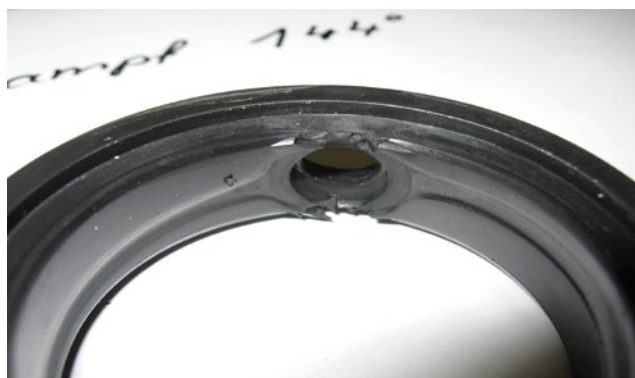
The result is that the valve no longer closes properly, which means that the liquids are no longer dependably separated, resulting in product contamination. For example, if the flap is no longer being positioned in a 90° configuration, the feedback signal from the proximity sensor is not being sent, and the system goes into fault mode, which entails substantial costs in terms of lost production output (Figure 2).

Figure 2. Swelling of the seal, with tear, in conjunction with imprecise closing of the butterfly valve.

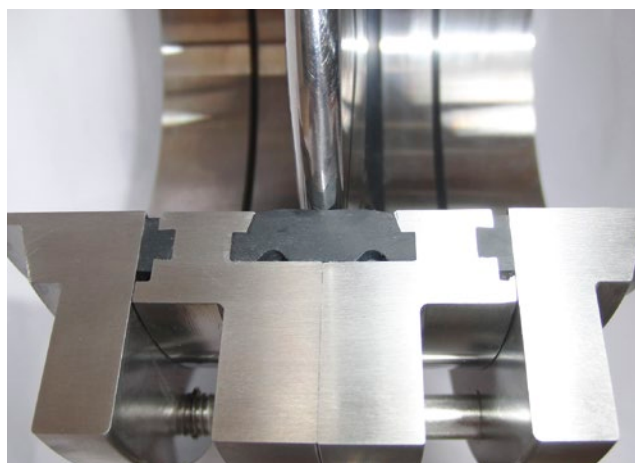
With a seal design that incorporates two expansion grooves the expansion caused by a change in temperature can be purposefully confined to the seal's installation space in the housing, and the abrasion or damage in areas coming into contact with the product can thus be avoided (Figure 3).

Figure 3. Cross-sectional view of a butterfly valve with optimum installation situation for the seal.

And in order to prevent wear phenomena due to valve flap movements, a smooth surface has been provided in the product compartment, thus relocating the dividing line to outside the product area. A lead-in chamfer on the seal

supports the switching mechanisms of the disc, so that all switching operations are performed with minimum stress on the material.

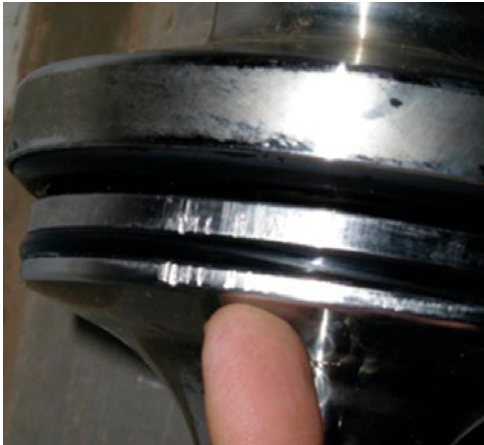
Similar phenomena can be observed with mix proof valves. Damage to the radial seal and traces of wear at the valve disc can be prevented by providing a defined installation space for the seal, and by designing the seal with a support ring (Figure 8).

Figure 8. Traces of wear on the valve disc.

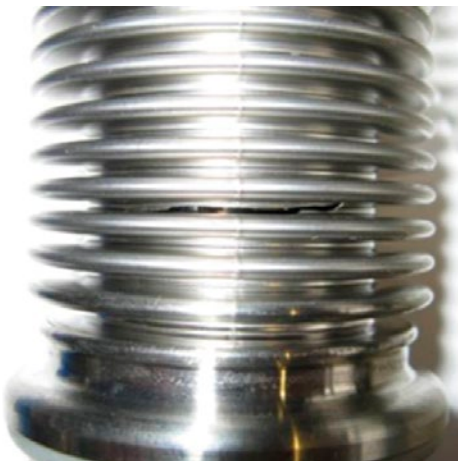
The requirements involved are even more stringent in aseptic operations. Dependable separation of the product from its surroundings has been the strategy pursued for many years now. Integrating the bellows elements as a seal at the valve disc can indeed create the desired separation; however, this introduces a not-inconsiderable source of possible malfunctions. Defective bellows and the concomitant possibility of rear infiltration may be responsible for contamination phenomena not amenable to easy detection, causing substantial losses of productivity in actual operation quite apart from a contamination of the product involved (Figure 10).

Figure 10. Damage to the bellows means that contamination is inevitable.

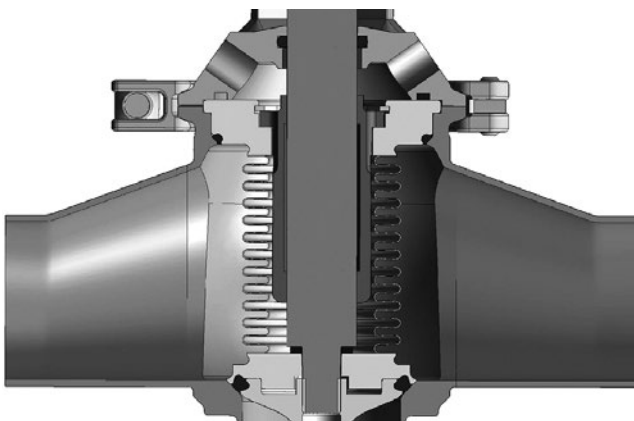
A study of the stresses acting on the stainless-steel bellows under a flow of  $p = 7$  bar shows unequivocally (with different process parameters and stroke positions) what vibrations occur in the bellows construction. This quickly reveals why a bellows breaks after only a very brief period of operation. In the newly designed valve series, this is remedied by an integrated support body (Figure 11), which ensures that the bellows is properly guided and dampens the vibrations at the individual pleats. Moreover, this also avoids damage to the bellows due to overstressing at removal.

Figure 11. Support body for guiding the bellows.

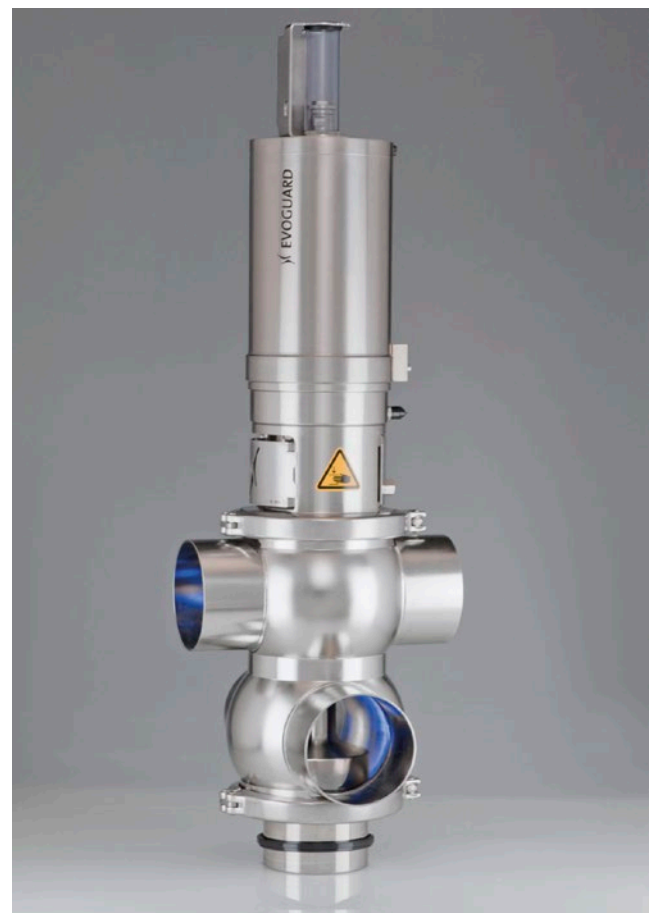
With a welded version of the actuator (designed for one million switching cycles), the amount of maintenance work required is minimised, while the accident risk from opening up an actuator is eliminated as well. In this context, special attention has been paid to easy handling of the actuators, as evidenced by the weight of  $< 25$  kg in the case of nominal diameters of up to ND 100. In addition, accident prevention in production mode is enhanced by covers for moving parts (valve yoke, feedback system) (Figure 12).

Figure 12. Personnel safety – protective feature at the valve yoke and feedback system
